Manhole Inspection Summary

Manhole # S31A__030MH

Location Address: **555 SEMINARY COURT**

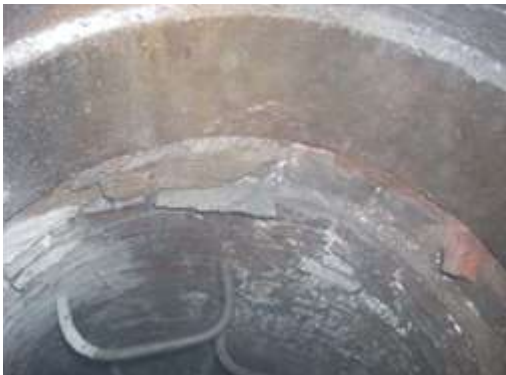
Defect 1

Condition: ☐ Sound ☐ Cracked ☐ Root Intrusion ☐ Loose Brick ☒ **Deteriorated**

CHIMNEY DETERIORATED CHIMNEY

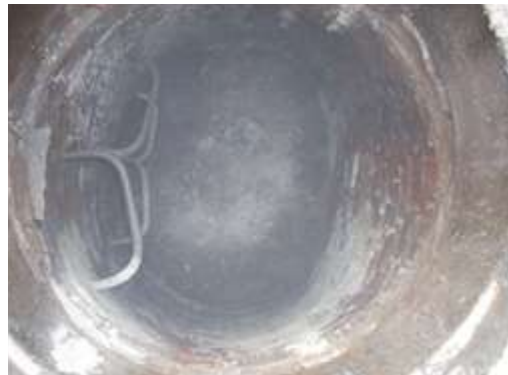
Defect 2

Condition: ☐ Sound ☐ Cracked ☐ Root Intrusion ☐ Loose Brick ☒ **Deteriorated**

Condition: ☐ Sound ☐ Cracked ☐ Root Intrusion ☐ Deteriorated ☐ Leaks ☒ **Debris**

deteriorated corbel; debris

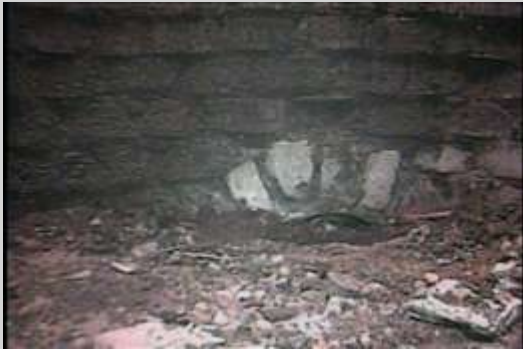
12 O'Clock Outflow

8 in. Circular Gravity Sewer
Pipe Out @ 12 O'Clock

Deposits: ☐ None ☐ Mud ☐ Sludge ☒ **Debris** ☐ Grease

Silt Depth: **8** (in.) Deposits Extent: **Heavy**
